NASA TN D-8150

PERFORMANCE OF LI-1542 REUSABLE SURFACE
INSULATION SYSTEM IN A HYPERSONIC STREAM

*L. Roane Hunt, John L. Shideler,
and Irving Weinstein*

*Langley Research Center
Hampton, Va. 23665*

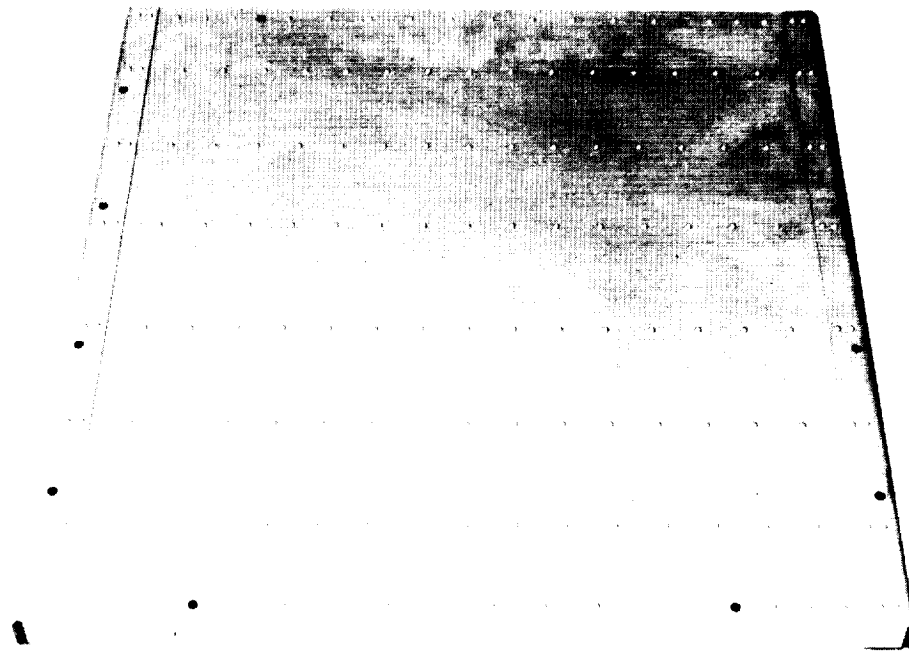
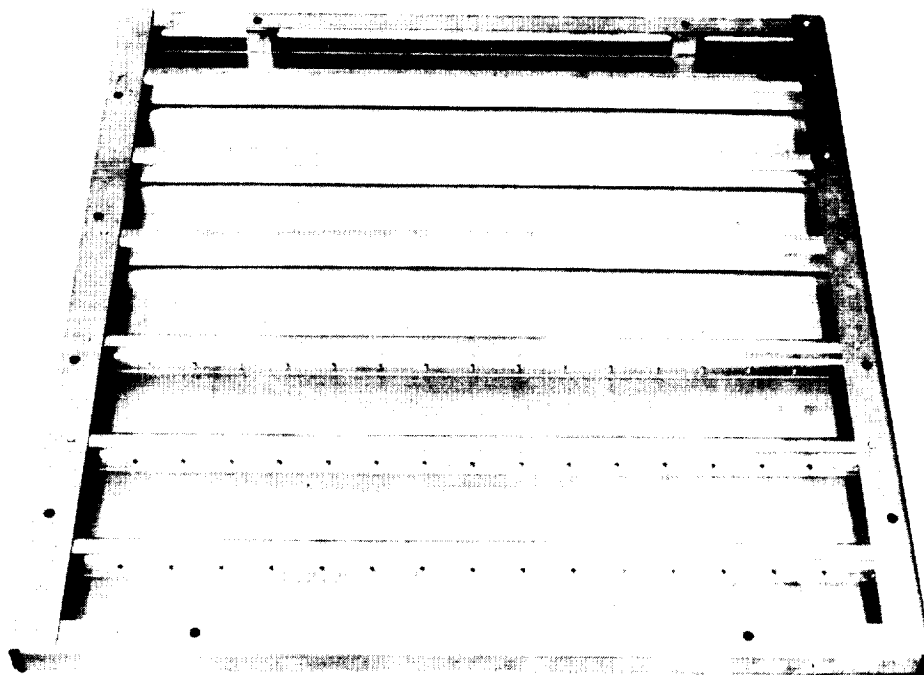
Figure 2.- Stringer-stiffened beryllium subpanel. L-76-101

The stringer-stiffened beryllium subpanel, shown in figure 2, is the basic structural unit of the test panel. Each subpanel supports four RSI tiles, is 55.9 cm square, and is fabricated from 1.0-mm sheets. The subpanels were attached along their periphery to the support frame with 12 rivets each.

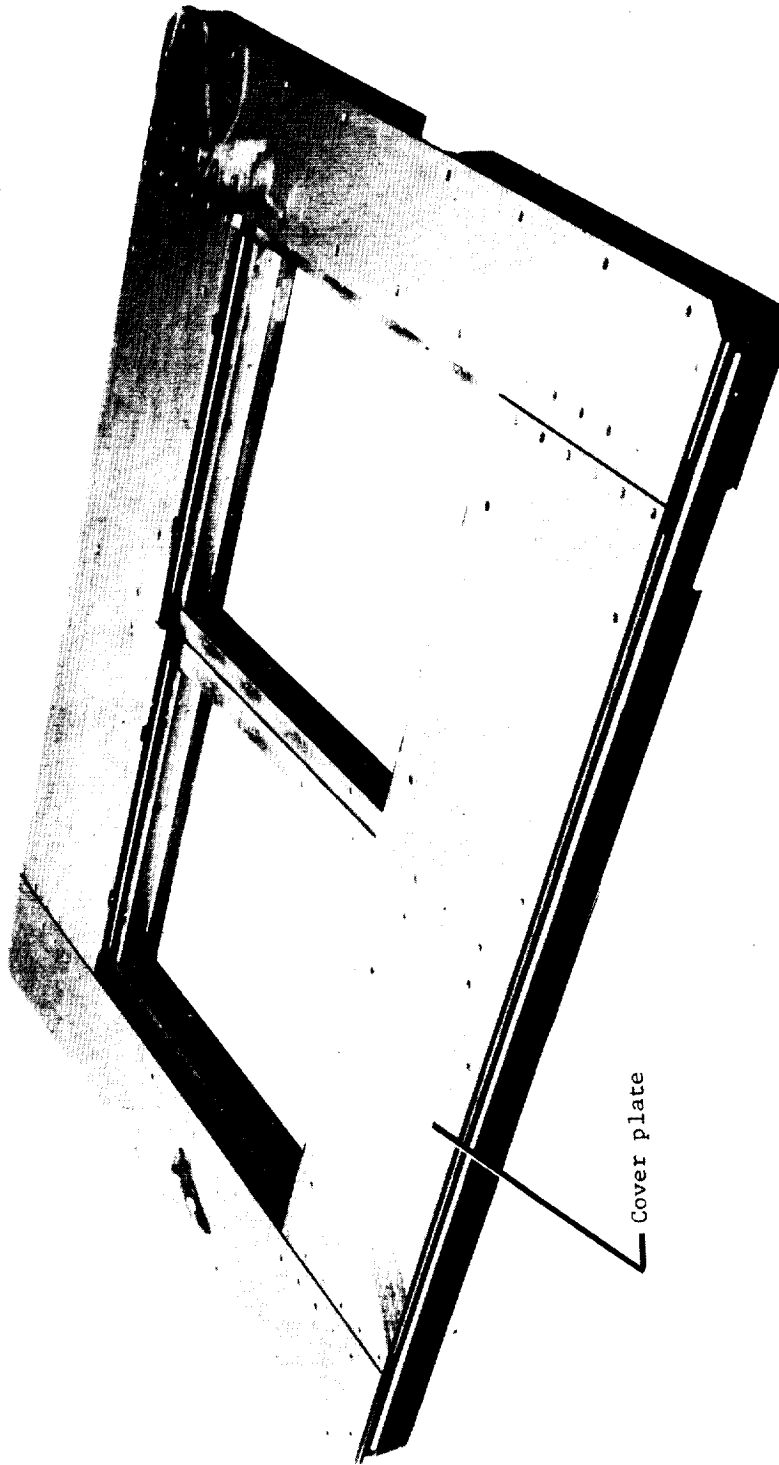
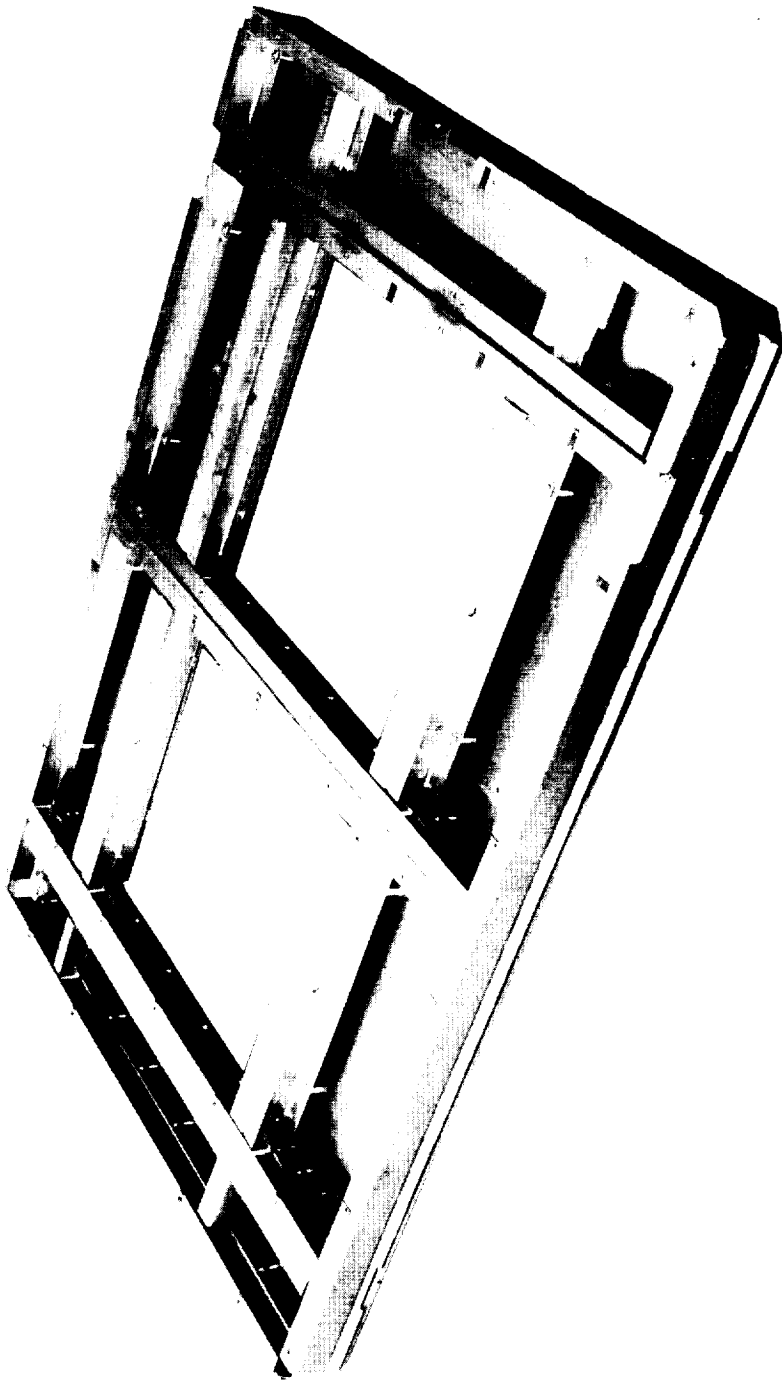
L-76-102

Figure 3.- Titanium frame.

The titanium frame, shown in figure 3, represents the primary structure which would support individual subpanels in a flight design. The top of the frame is covered by 0.64-cm-thick titanium plates around the area reserved for the two subpanels. The plates are held off the frame by spacers, and the peripheral tiles are bonded directly to these plates. Titanium channels, shown in the bottom view, have a web height of 6.0 cm, flange width of 3.18 cm, and a thickness of 0.127 cm. An aluminum plate (0.8 mm thick) was attached directly to the bottom of the frame to absorb the internal radiation of the test panel.

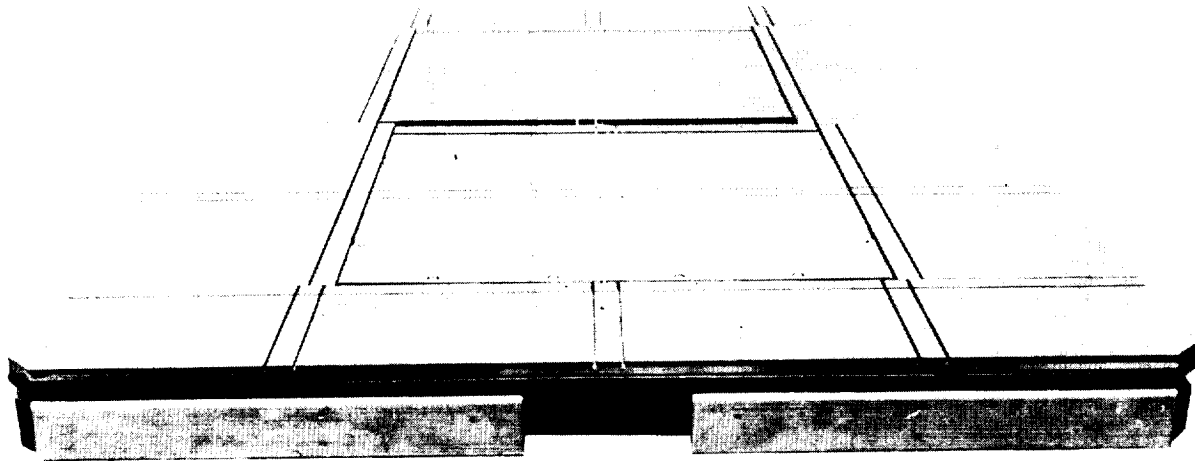
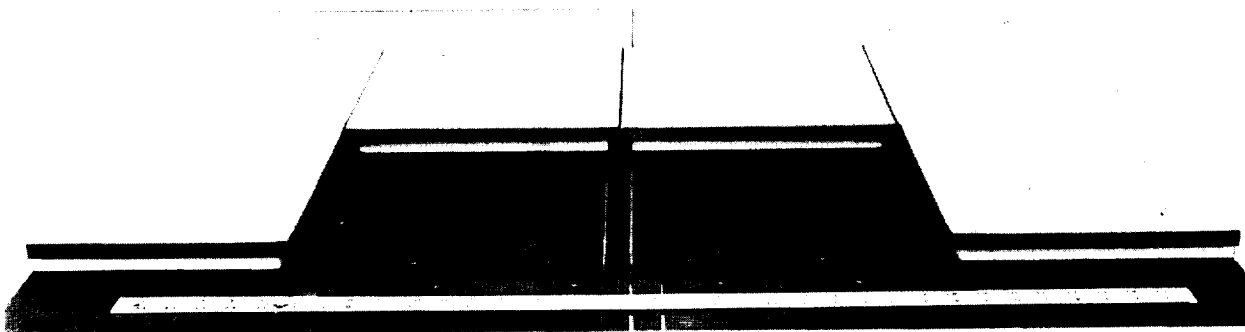
L-76-104

Figure 4.- Tile assembly.

The tile installation procedure is illustrated in figure 4, which shows the titanium frame with subpanels attached. The procedure began by covering the entire upper surface of this assembly with a 0.23-cm-thick layer of silicone rubber (RTV 560). This layer served as a strain isolator for the RSI tiles. Before the rubber hardened, strips were placed in the rubber to outline the tile positions. When these strips were removed, a groove pattern remained that isolated the tiles as shown in figure 4(a). The tiles and a thermal seal between tiles were then bonded in place with a very thin layer of RTV 560. The tile placement relative to the groove pattern is illustrated in figure 4(b).

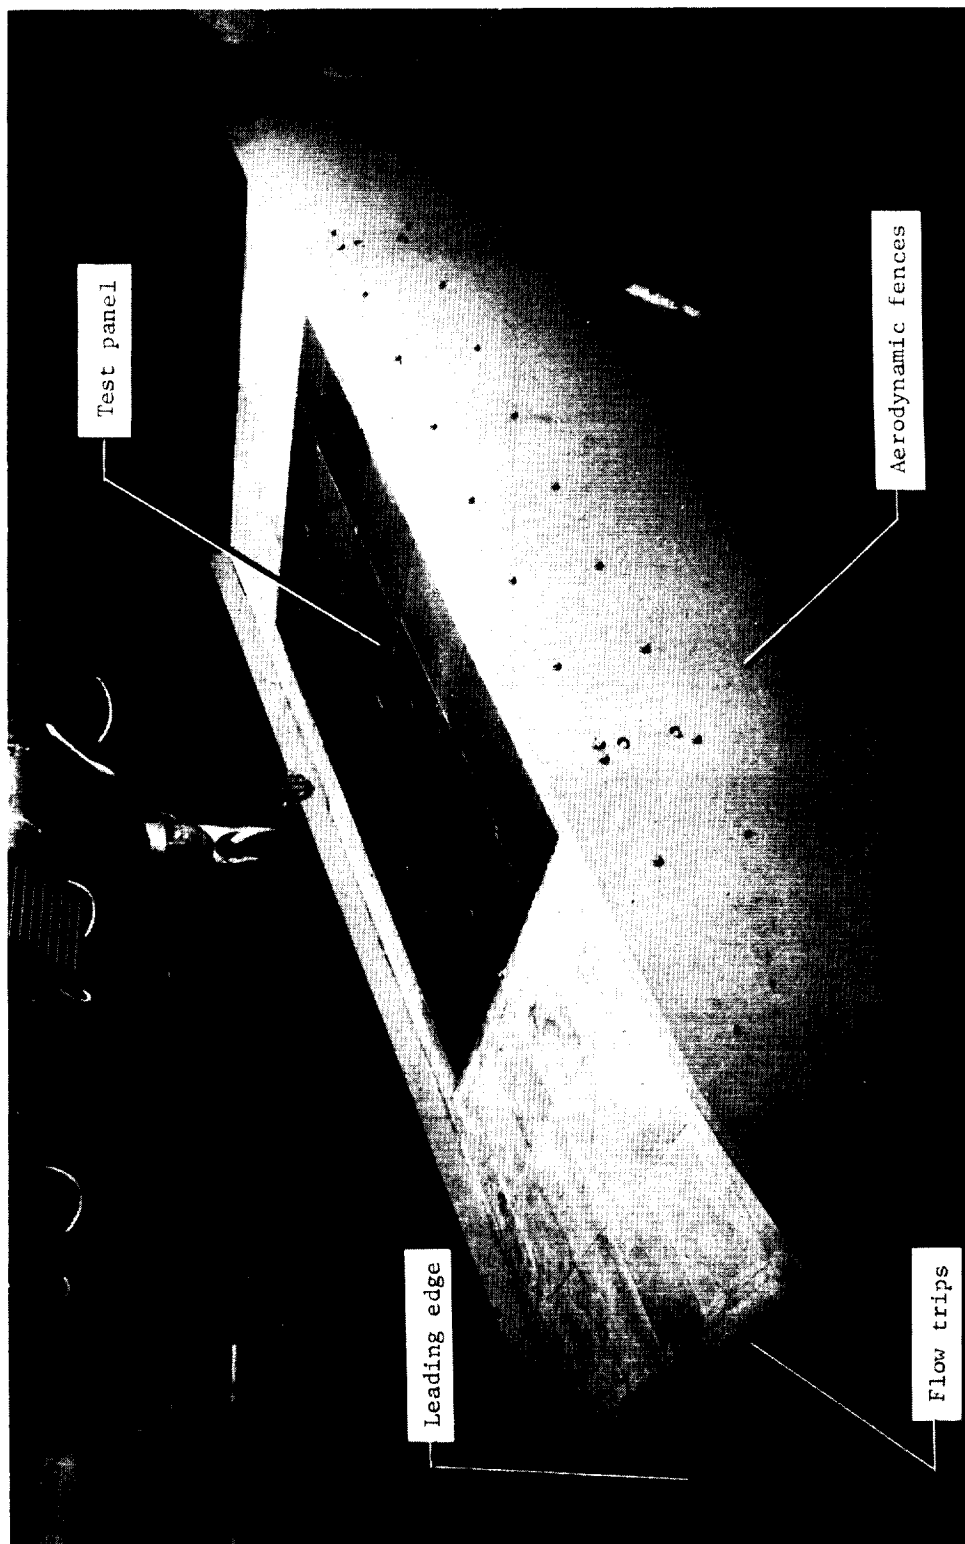
L-76-105

Figure 6.- RSI test panel installed in panel holder of Langley 8-foot high-temperature structures tunnel.

TPS panel tests were performed with the panel holder shown in figure 6. The panel holder is a rectangular slab 141 by 300 cm with a 20° bevel at the leading edge. A cutout, that can accommodate test panels up to 108 by 152 cm, is located 102 cm from the leading edge. Tests are made by use of the panel holder pitched at angles to the test stream varying from 0° to 15° . The panel holder has boundary-layer flow trips and aerodynamic fences to provide uniform aerodynamic pressure and heat-transfer loading to the test panel surface. A single row of spheres, spaced across the panel holder width 12.7 cm from the sharp leading edge, trips the boundary layer to provide turbulent flow over the test surface. Aerodynamic fences on the side edges of the panel holder extend 7.6 cm above the test surface to channel the flow over the test surface when the holder is pitched relative to the stream. The fences extend 25 cm below the bottom of the holder to prevent vortical flow spilling on to the test surface from the bottom surface at angles of attack near zero. The maximum surface pressure and cold-wall heat-transfer rate possible for the available test conditions are 15 kPa and 250 kW/m^2 , respectively. The flow calibration of the panel holder is described in reference 7.

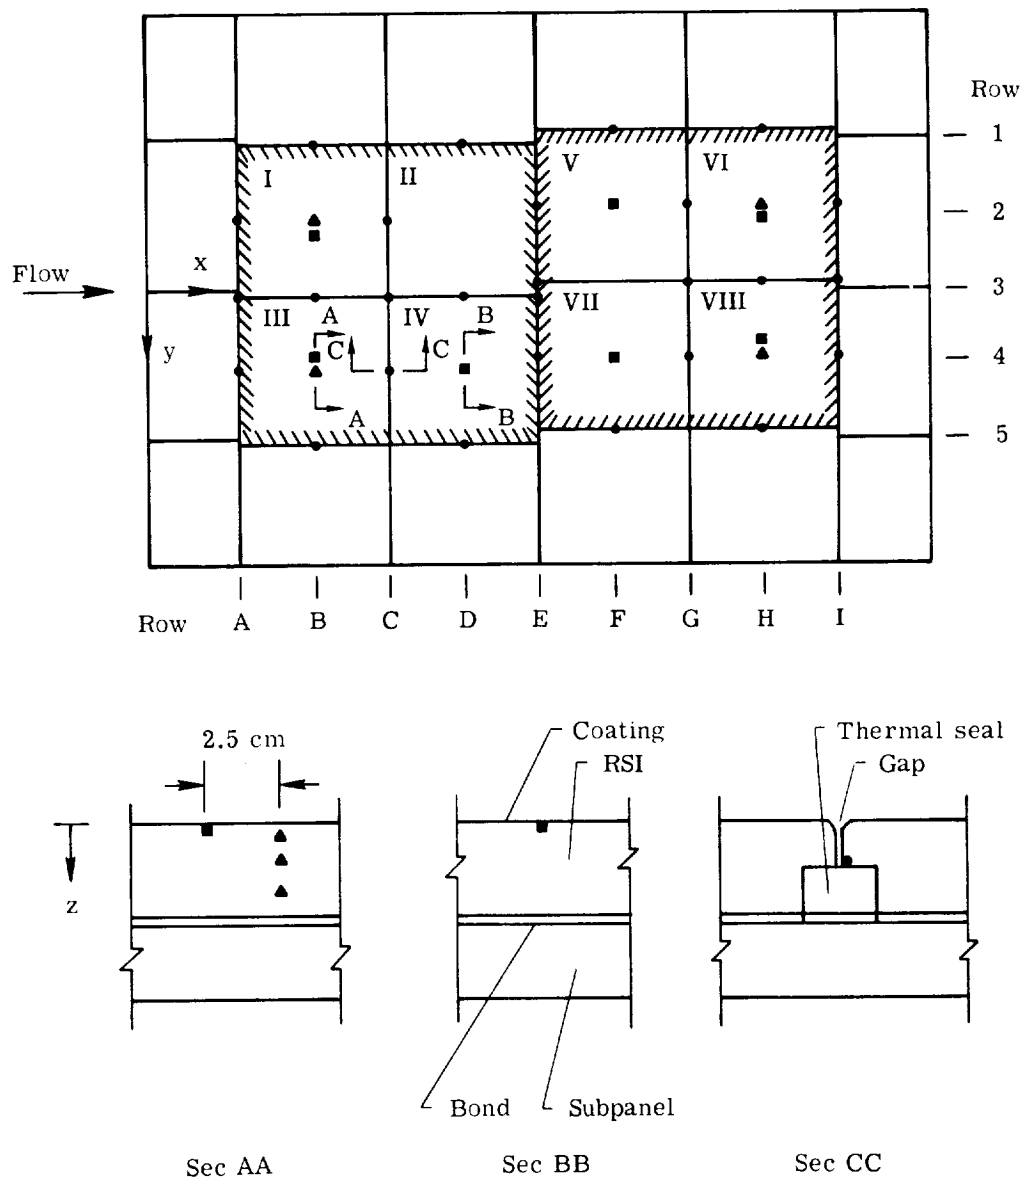
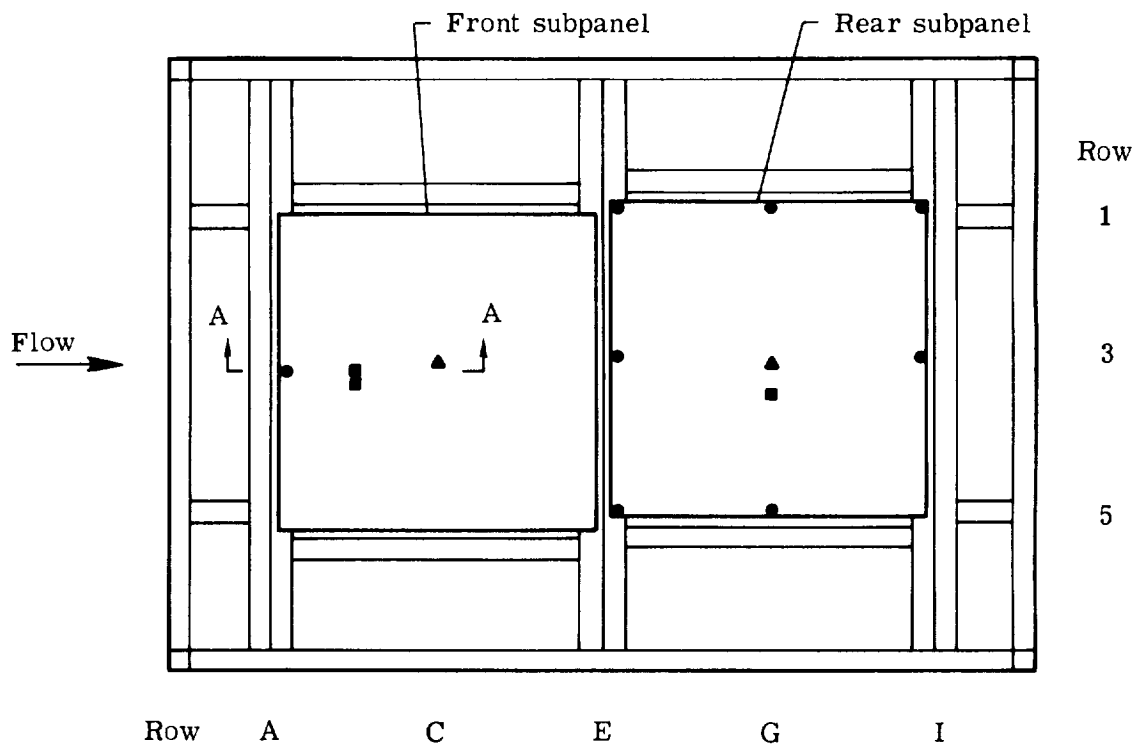
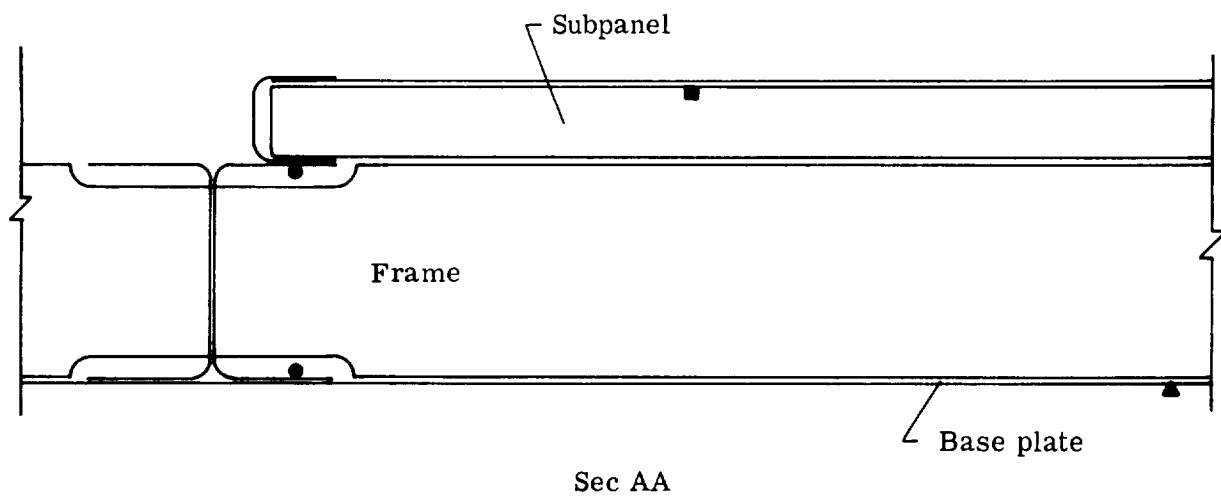
Figure 7.- Test panel with thermocouple locations indicated.

(b) Subpanels and support frame.

The test panel is instrumented with 65 thermocouples (TC): 45 in the RSI tiles and 20 on the subpanel and support frame. The locations of these thermocouples are indicated in figure 7 by symbols. Figure 7(a) shows thermocouple locations for the subpanel tiles identified by Roman numerals. Figure 7(b) shows thermocouple locations on the subpanels and support frame. The Cartesian coordinates and the alphanumeric system shown in figures 7(a) and 7(b) will be useful in discussing results subsequently.

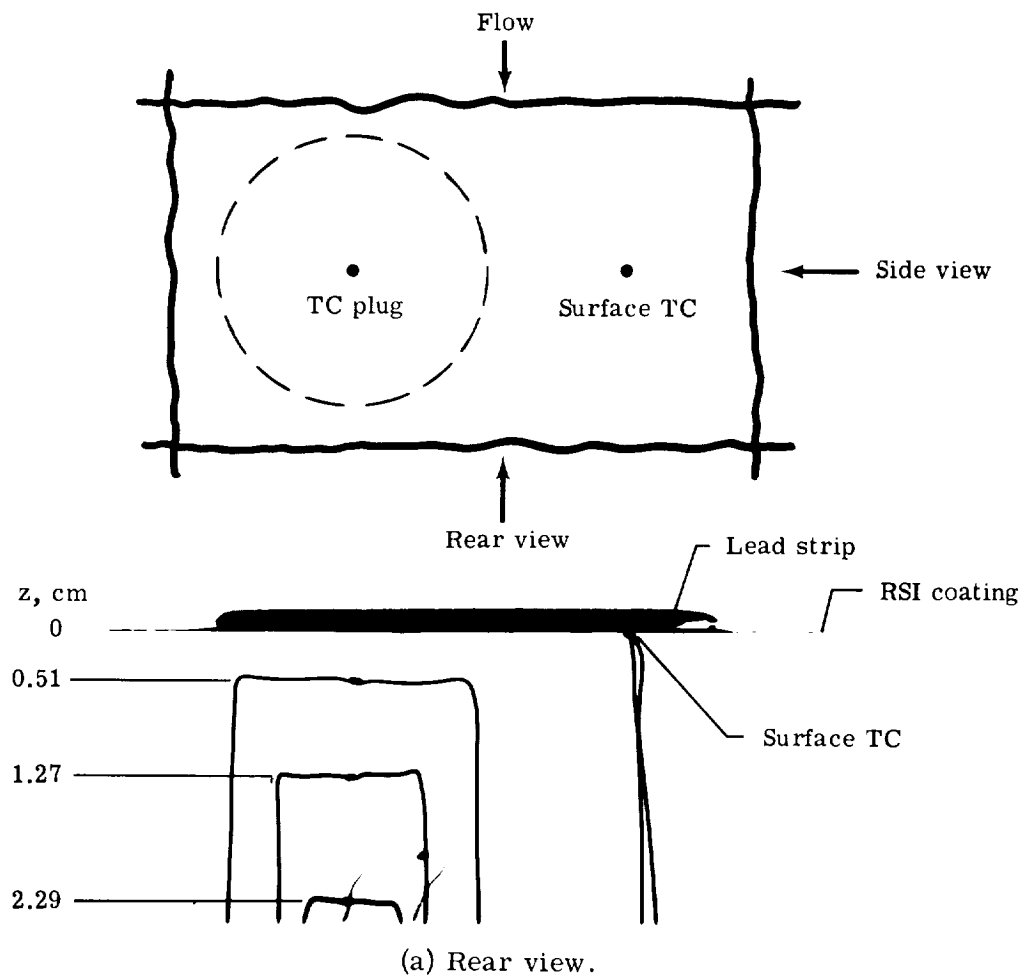
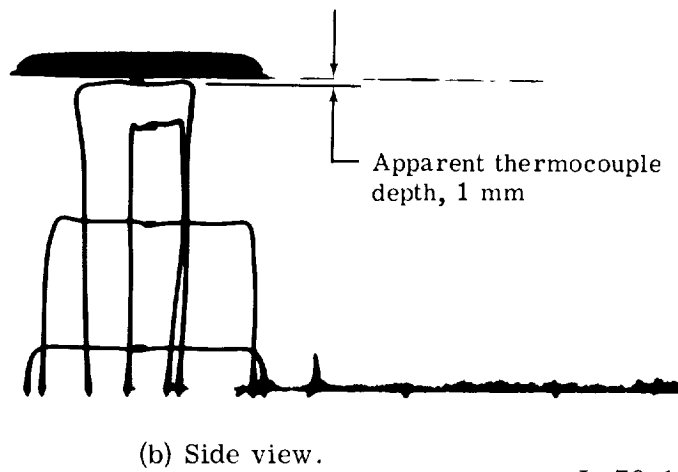
L-76-106

Figure 8.- X-ray photograph of thermocouple (TC) instrumentation.

The thermocouples located in the RSI tiles were prescribed to be at the top surface and at depths of 0.51, 1.27, and 2.29 cm from the top surface. They were embedded in plugs of insulation which were then inserted into holes in the tile before the tile was coated. To verify the location of the thermocouples, X-ray photographs were taken of a typical thermocouple plug after the tests, and two views are presented as figure 8. The thermocouples seem to have been located properly; however, the surface thermocouple appears to be at a depth of about 1 mm. The bead extends up to the coating, but the lead wires are parallel to and below the top surface. The effective depth of this thermocouple was assumed to be the depth of the lead wire.

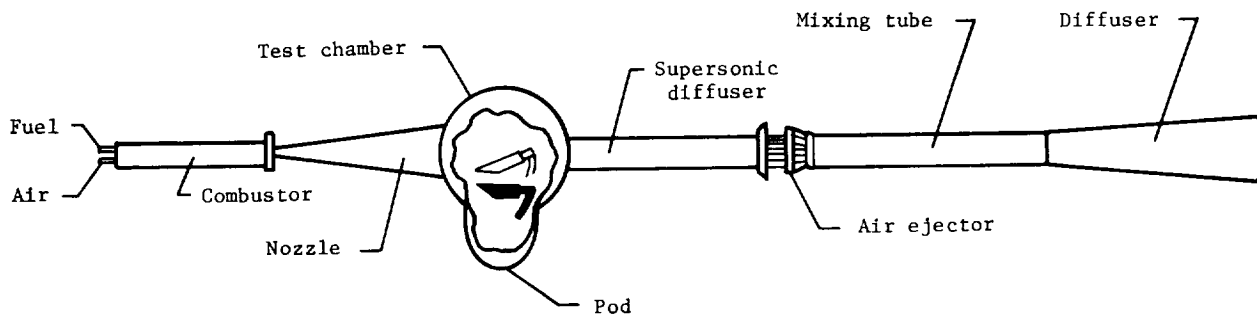
Figure 9.- Langley 8-foot high-temperature structures tunnel.

The tests were conducted in the Langley 8-foot high-temperature structures tunnel (HTST) shown schematically in figure 9. This facility is a hypersonic blowdown wind tunnel that uses the combustion products of methane and air as the test medium and operates at a nominal Mach number of 7, at total pressures between 3.4 and 24.1 MPa, and at nominal total temperatures between 1400 K and 2000 K. Corresponding free-stream unit Reynolds numbers are between 1×10^6 and 10×10^6 per meter. These conditions simulate the aerothermal flight environment at Mach 7 in the altitude range between 25 and 40 km. As indicated in figure 9, the panel holder is retained in the pod below the test chamber during facility startup and shutdown so that the panel is exposed only to the desired stream conditions.

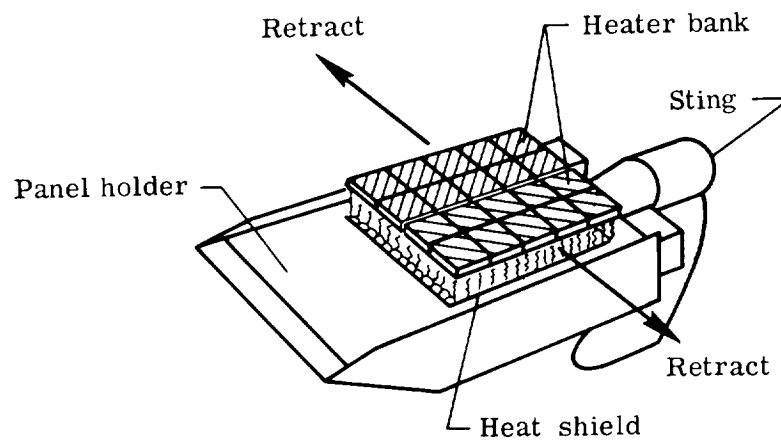
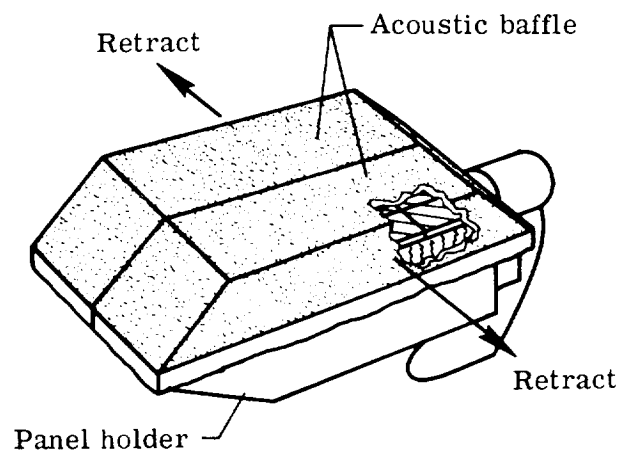
Figure 10.- Retractable radiant heaters with and without acoustic covers.

Although the facility provides aerodynamic exposure times of up to 120 seconds, thermal exposure times can be extended indefinitely by means of a pair of retractable quartz-lamp radiant heaters located in the pod. These heaters and the entire test surface of the panel holder are covered by a pair of acoustic baffles which protect the panel from potentially damaging acoustic disturbance and buffeting generated during facility startup and shutdown. Sketches of the radiant heaters and acoustic baffles are shown in figure 10. The sketches in figure 11 show the panel holder covered by the heaters during pretest and posttest conditions and also show the panel holder in test position with heaters retracted. Additional information pertaining to this equipment and the test facility may be found in references 7 and 8.

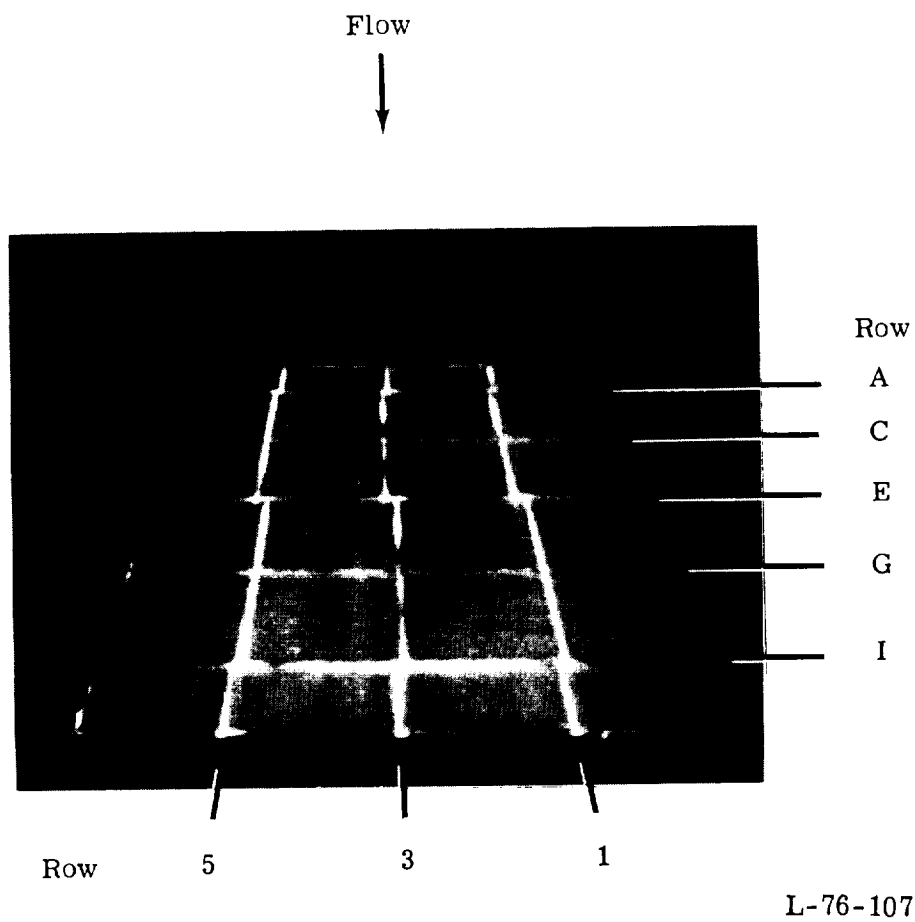
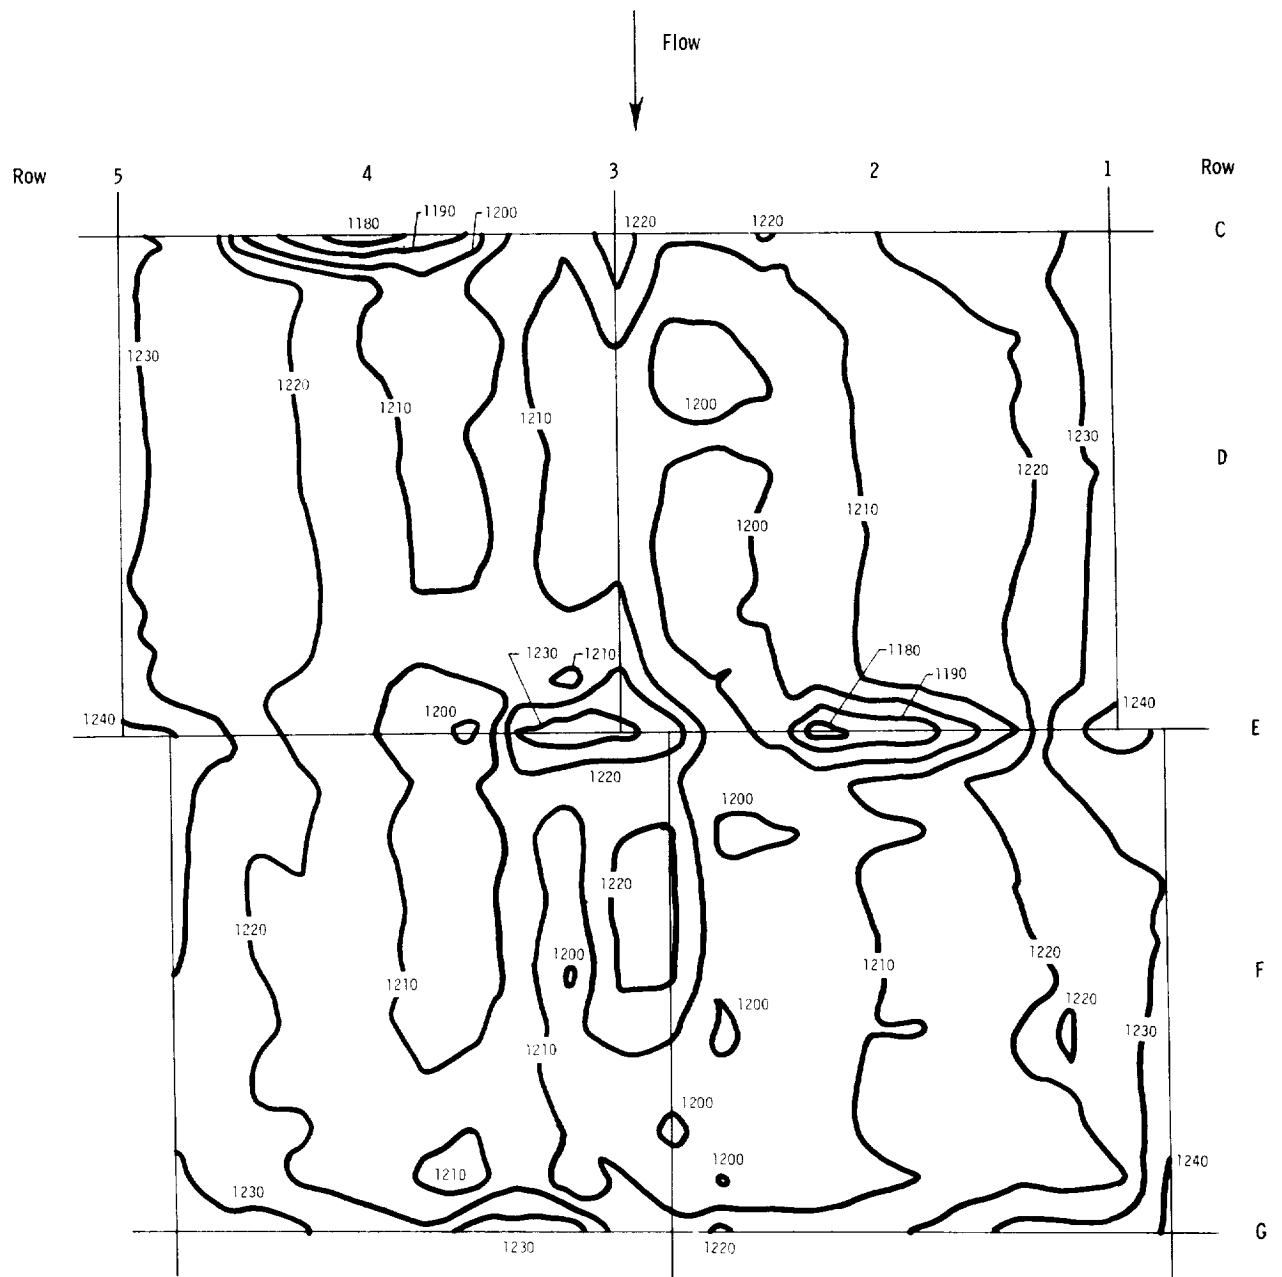
Figure 15.- Hot panel during aerodynamic heating of mode III test (test 10).

A photograph of the visible glow of the hot RSI surface produced by aerodynamic heating during test 10 is shown in figure 15(a). The tile surfaces are glowing at a temperature of about 1210 K. The glow along tile edges is significantly brighter than that of the surface, to the extent that the tile arrangement of the panel is outlined, and indicates that temperatures there are considerably higher than those on the tile surface. Moreover, even hotter spots caused by stagnating flow at the ends of longitudinal gaps are clearly defined at the "tee" intersections of gaps along rows A, E, and I with gaps along rows 1, 3, and 5. The glow in the longitudinal gaps at the subpanel border joints (rows 1 and 5) is much brighter than that of the interior gap along row 3. This excessive heating was subsequently attributed to flow leakage past the border joint seals (fig. 5(a)) and discussed in a later section. The glow in the lateral gap along row I is brighter than in other lateral gaps and resulted from exposure of the lower emissivity insulation material caused by erosion of the coating.

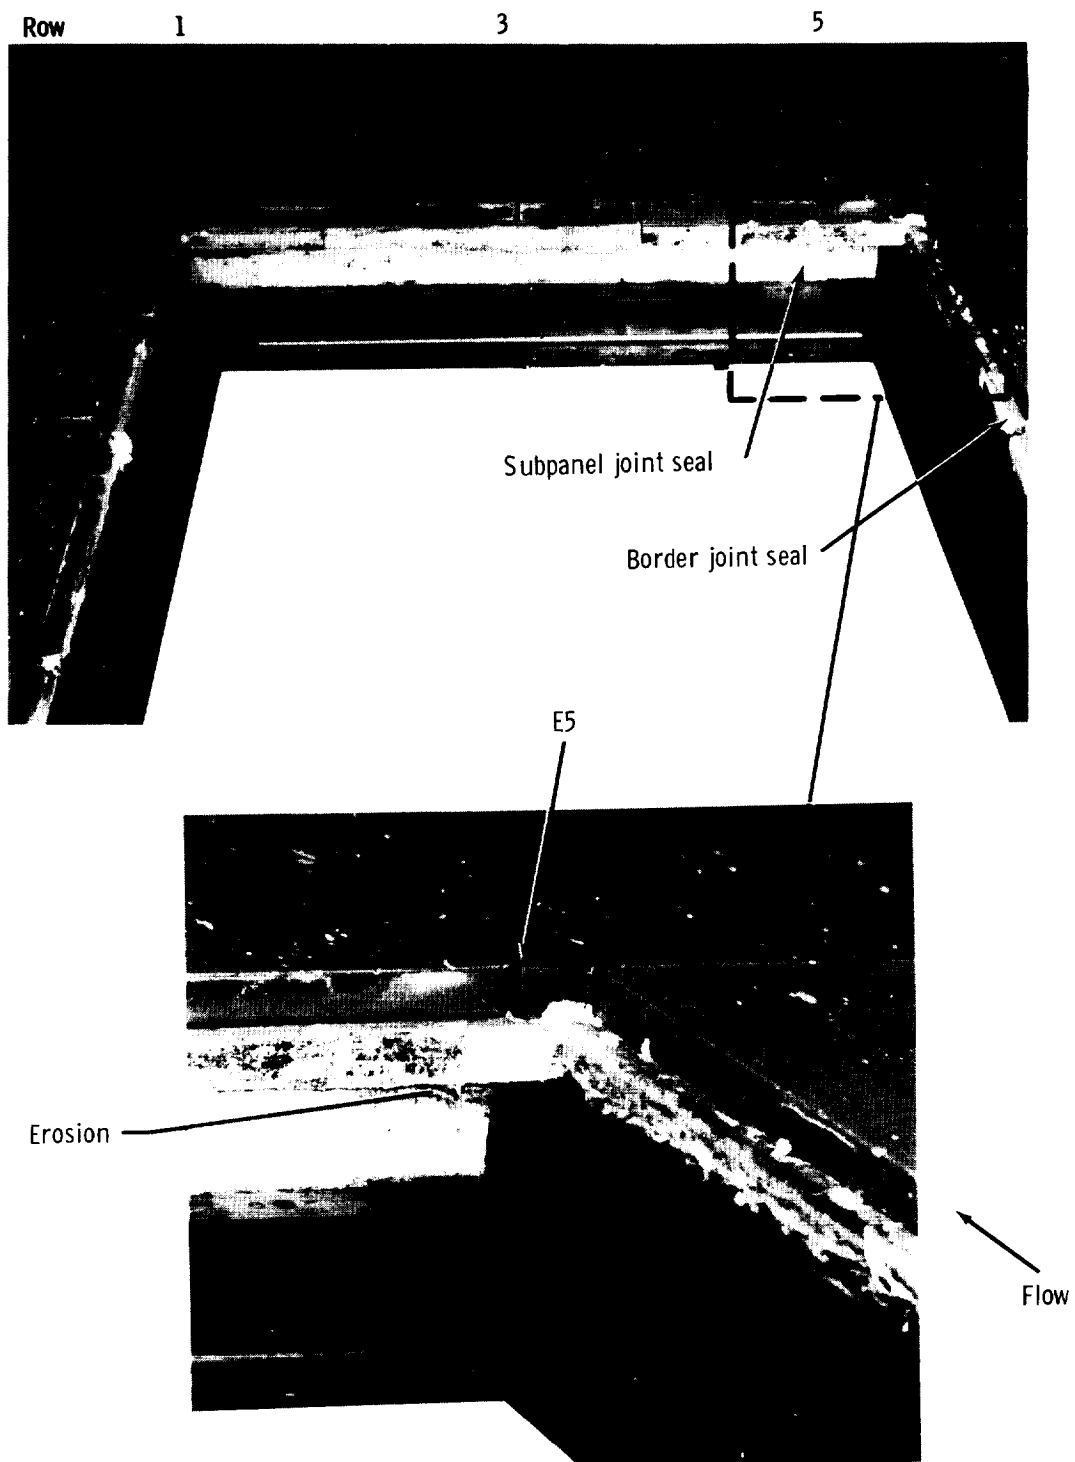
L-76-108

Figure 20.- Thermal seals of subpanel joint E5 at conclusion of tests.

Additional evidence of gas leakage was obtained when the subpanels were removed after these tests. The photographs in figure 20 show the panel with the forward subpanel removed. Much of the fibrous thermal seal was damaged during disassembly. Note that the deep, subpanel joint seal does not extend to the corner E5 where the highest substructure temperature was observed. (See fig. 19.) In this corner, gas leakage caused considerable erosion of the seal and of the silicone rubber bonding material. Therefore, in the present test, these seals did not provide adequate thermal protection to the substructure in the presence of differential pressure.

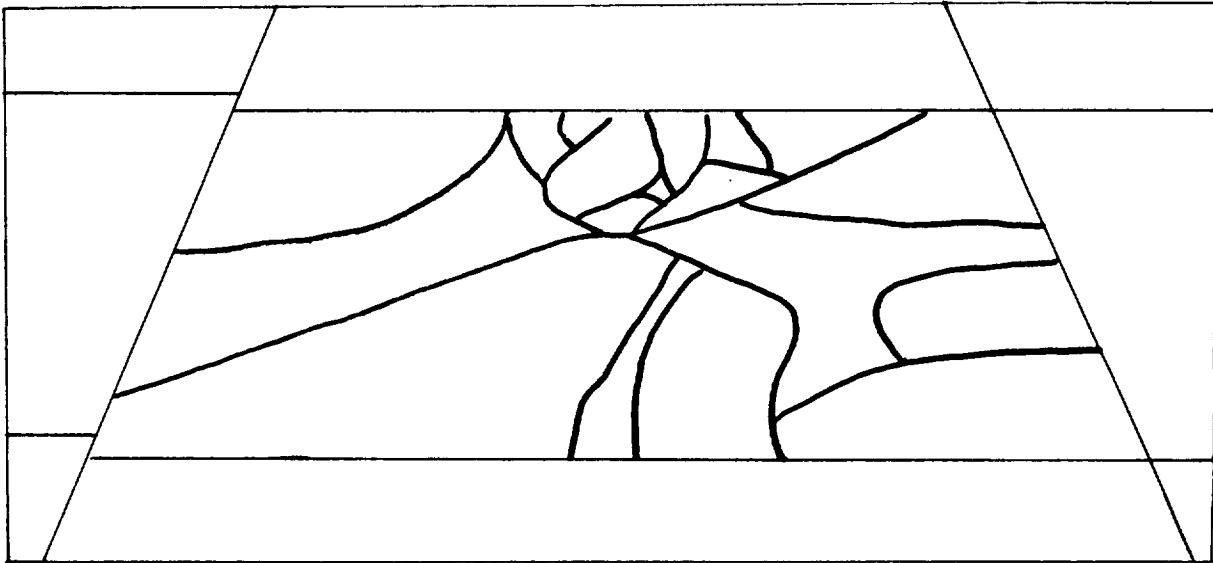
L-76-112

Figure 24.- Crack patterns of tile coating (tile III).

Coating cracks.- Cracks in the tiles, which were invisible to the naked eye, were detected at the beginning of the test program by wetting the surface with a volatile solvent. Actually, the first cracks were detected during panel inspections prior to initiating the first thermal cycle. A typical crack pattern in tile III (fig. 7(a)) is illustrated in figure 24. The crack pattern obtained prior to test 4 is shown in figure 24(a). After test 4, all the tiles were crazed similar to the tile shown in figure 24(b), but the crazing did not worsen with repeated testing. Test 4 was a mode II test in which the panel, at ambient temperature, was inserted into the hot, wind-tunnel stream. This test was the first mode II test that was conducted at the most severe test condition, but combustor flameout occurred after about 6.2 seconds of testing. The total temperature of the stream dropped to about the ambient temperature level as the panel was being removed from the stream. Thus, the panel experienced rapid heat-up and cool-down in this test. The results of the thermal stress analysis presented in appendix B for the two extreme temperature gradients indicated that tensile stress in the tile coating associated with a rapid cool-down was about 83 percent of the allowable stress. Consequently, the failure of the coating was probably due to factors other than thermal stress alone. Although the tile coating was badly crazed, the tiles demonstrated good structural integrity and surface toughness throughout the remainder of the test program.

To assess the cause of the crazed coating observed after test 4 (see fig. 24), the tile was analyzed for two temperature conditions which occur as a result of the sudden heat-up and cool-down imposed on the RSI during test 4. These two conditions were as follows: (1) the coating temperature was 1144 K and the insulation was at a uniform 295 K, which was the most severe temperature difference possible for causing compres-

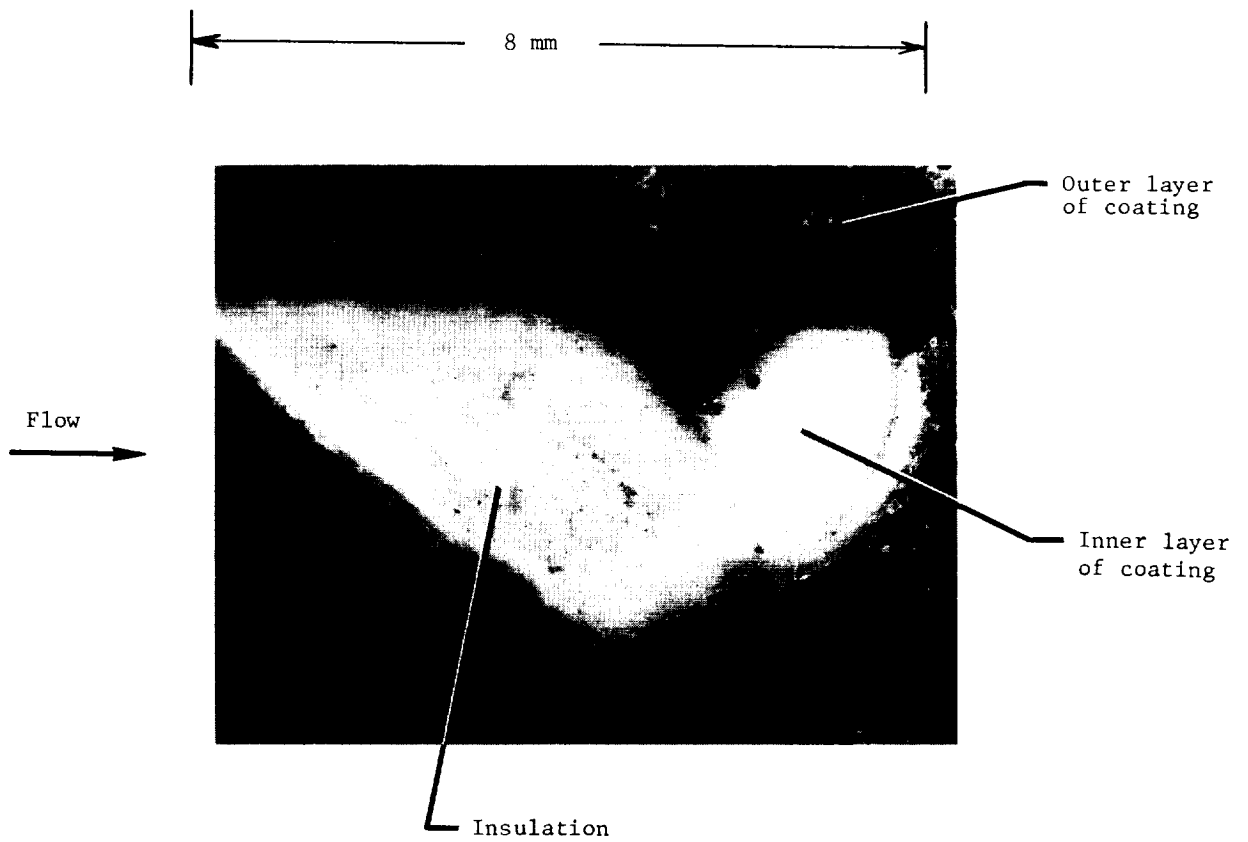
L-76-113

Figure 25.- Flaking damage to water-soaked tile.

in the form of flaking of the coating as shown in figure 25. The flaking occurred mostly in the outer layer of the coating as shown on the right side of the photograph, but in some cases the flakes were deep enough to expose the insulation as shown on the left side. Although the flaking could have occurred along existing cracks, the typical flake damage differs in size and shape from the crazed areas such as those outlined in the crazed coating of figure 24. All the flaking occurred on the top surface within about 2 cm of the tile edges. This flaking is similar to that described in reference 12 as eruptions of the coating which occurred during thermal cycles of uncracked tiles after they had been exposed to water. As indicated in reference 12, eruption of flakes could have been caused either by outgassing of water vapor or by outgassing from oxidation of silicon carbide in the outer layer of the coating in the presence of water vapor. Therefore, the presence of water seems to be the key factor in producing coating eruptions in reference 12 and in the present test 23. The localized coating eruptions would decrease the reusability of the RSI tiles, but the damaged coating appears to be strong enough to prevent a catastrophic failure of the tile.

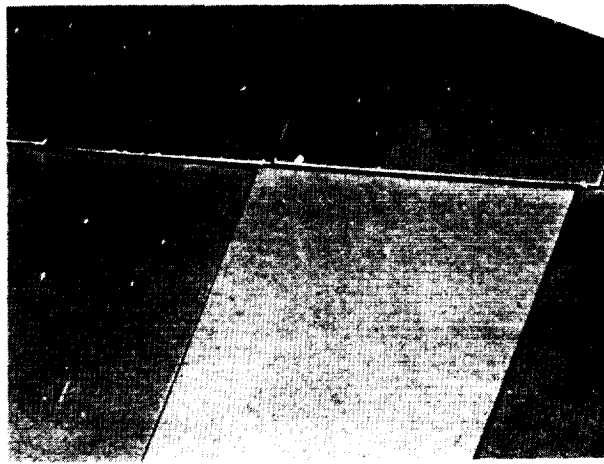
L-76-114

Figure 26.- Tile edge erosion of 0.4-mm forward-facing step along row I.

The most extensive erosion of a forward-facing step occurred along row I. The progression of the edge erosion of the 0.4-mm step is shown in figure 26. A large crater was produced in the tile edge during test 4 and was repaired (fig. 26(a)). Considerable erosion occurred during test 5 (fig. 26(b)), and the tile edge continued to erode in each successive aerodynamic exposure. At the conclusion of test 23 the panel had been exposed to 403 seconds of high shear flow, and erosion had progressed as much as 4 cm from the edge (fig. 26(c)).

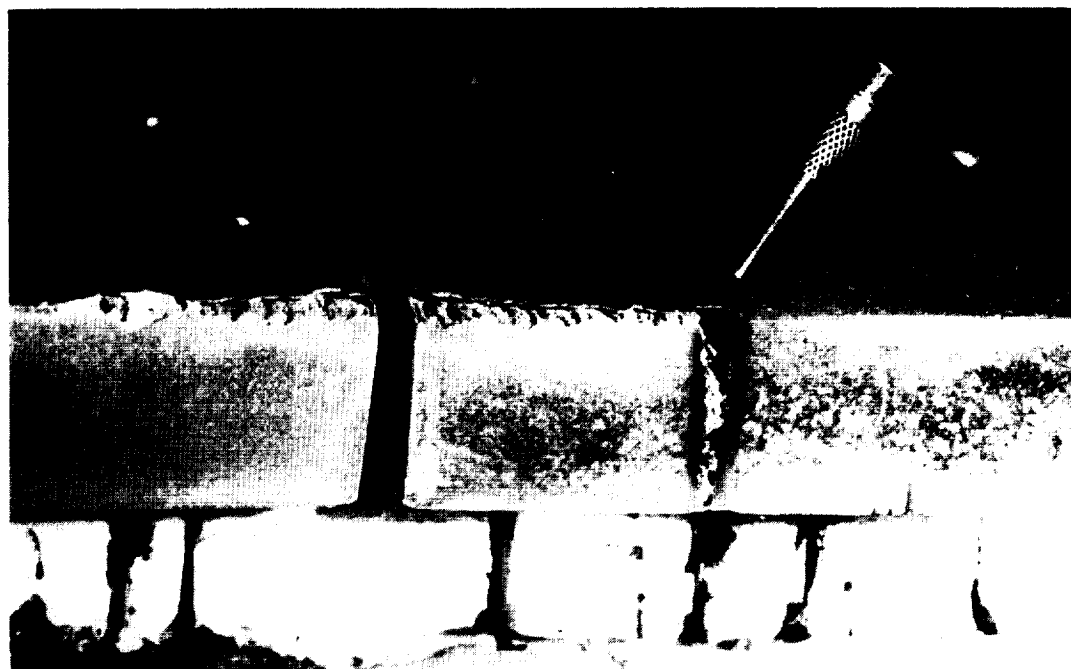
L-76-115

Figure 27.- Tile erosion from flow impingement at end of longitudinal gaps.

Typical erosion damage to the forward-facing walls of both subpanels at the ends of longitudinal gaps at locations A3 and E3 is shown in figure 27. Location A3 is at the end of a gap 18 cm long, whereas location E3 is at the end of a gap 58 cm long. (See fig. 7.) The erosion damage at A3 (fig. 27(a)) is less severe than at E3 (fig. 27(b)) and includes a number of small holes through the coating that were apparently produced by particle impact. At E3, both the upper edge of the tile and the wall were damaged by considerable erosion of coating and insulation materials. The upper edge of the tile eroded at this location because it formed a 0.6-mm forward-facing step, and the erosion in the wall

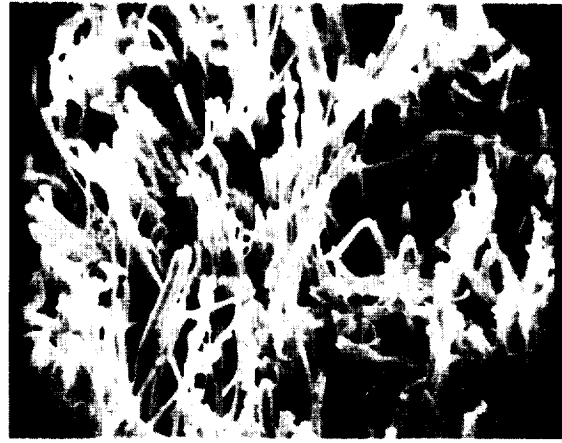
Figure 28.- Scanning electron micrograph (SEM) of erosion hole. L-76-116

produced a hole 1 cm deep within which melted silica fibers were seen. A photomicrograph of the erosion hole is presented in figure 28(a). Scanning electron micrographs of the insulation are presented in figures 28(b) and 28(c) for a magnification of about $\times 680$. It is apparent from figure 28(b) that the silica fibers at position "A" have been melted when compared with the undamaged fibers (fig. 28(c)) taken from unexposed areas near the damaged hole. However, the maximum stagnation temperature obtainable in the facility is too low to melt silica fibers. The melted fibers shown in figure 28(b) may have resulted from increased temperature associated with particle impact. Although it is clear that flow in longitudinal gaps stagnating on forward-facing walls is a source of high local heating (see ref. 11), it appears that the stagnating flow would not have produced any erosion without particle impact.
